REPORT ON THE CURRENT STATE- OF-ART ON PROTECTION, CONSERVATION AND PRESERVATION OF HISTORICAL RUINS

D.T1.1.1

12/2017

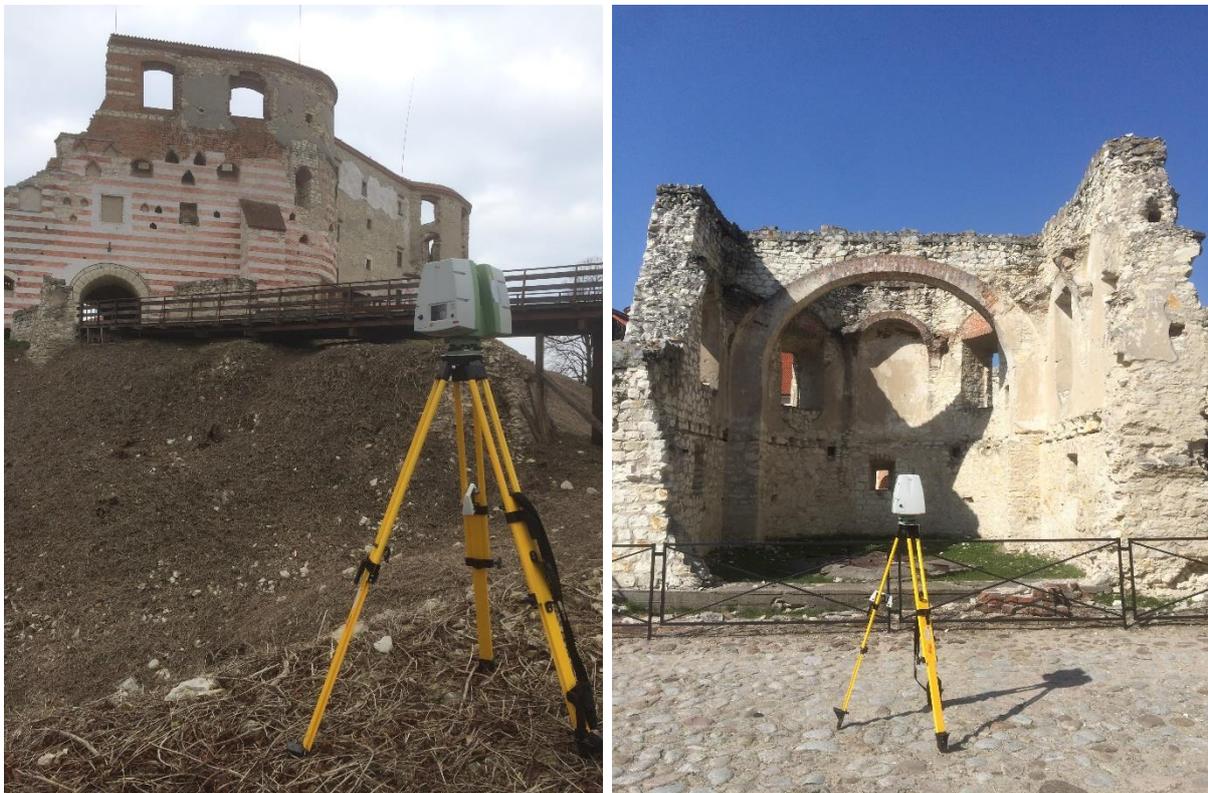
Photo 3 The Leica C10 scanner during field work at the Castle in Janowiec.

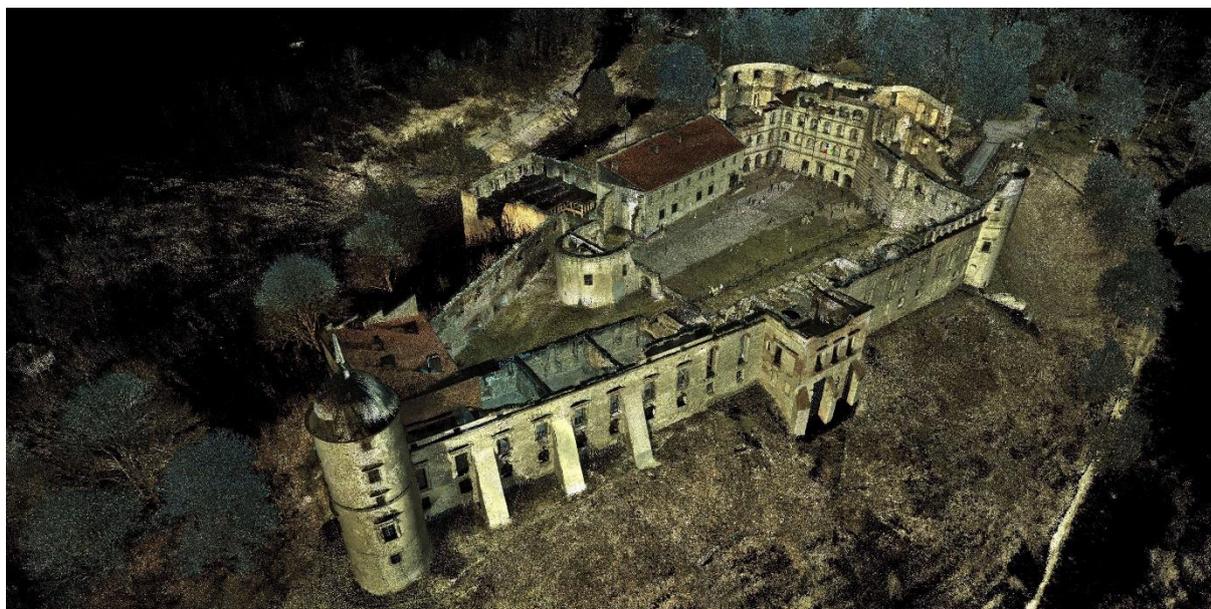
Fig. 1 The cloud of points, which was created as a result of the preparation of spatial data obtained from the Leica C10 scanner.

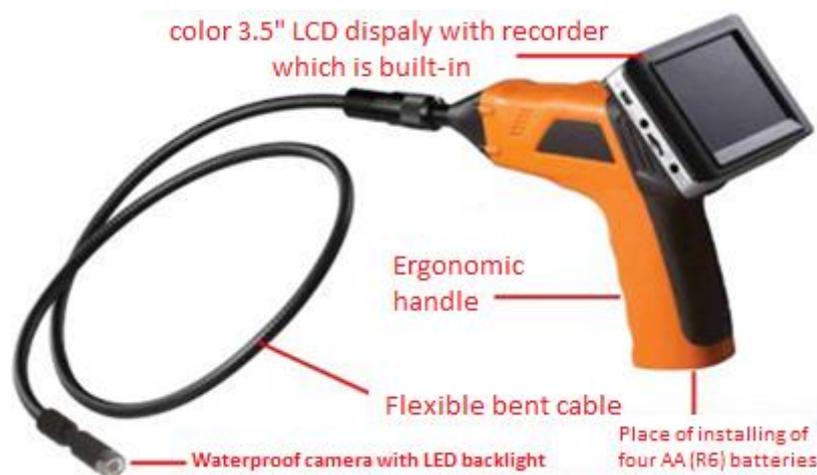
Fig. 4 The endoscopic camera with description (source: http://www.pay.pl/x/m/890LCD_BOX/opis_kamera.jpg)

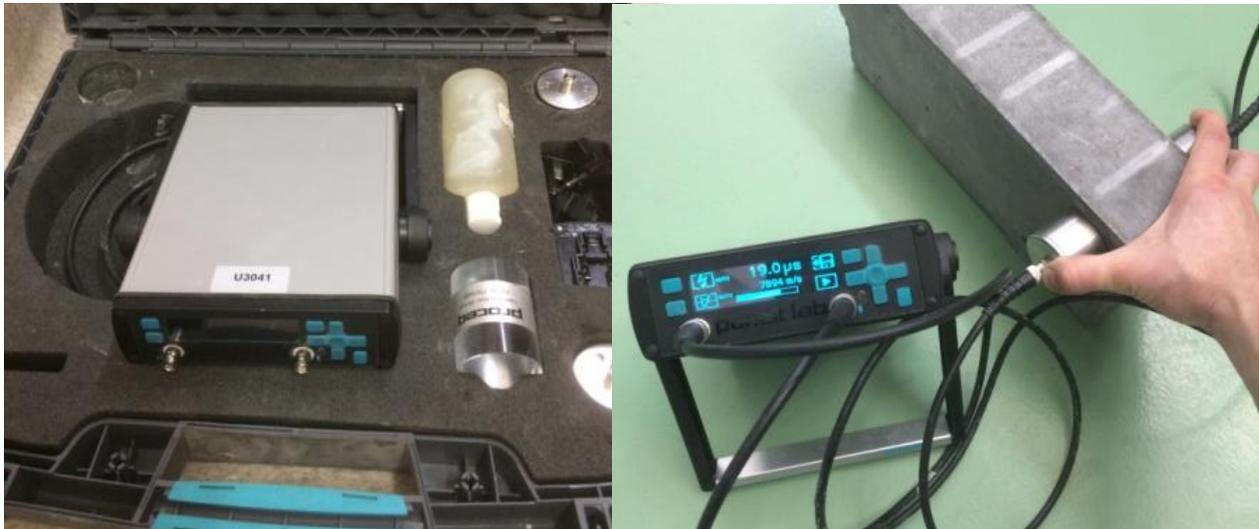
Photo 4 Ultrasonic testing equipment

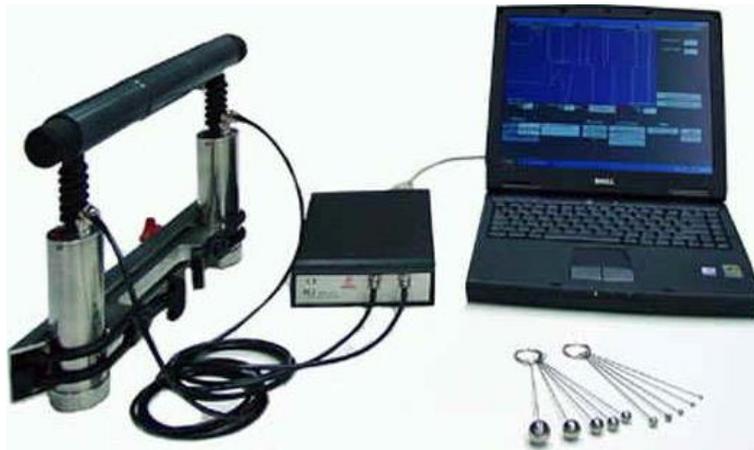
Fig. 7 Hammer test set (source: <http://www.impact-echo.com/Impact-Echo/images/wssetup.jpg>)

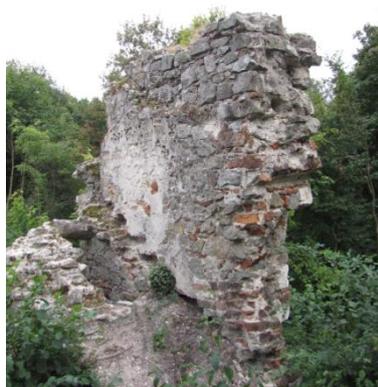
Photo9. Degradation of the wall due to the environmental factors /Międzygórz castle/

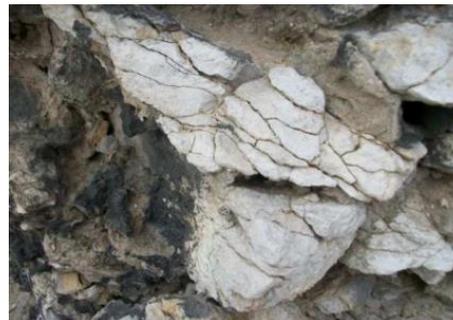
Photo10. Cracking of a masonry material /castle in Rabsztyn/

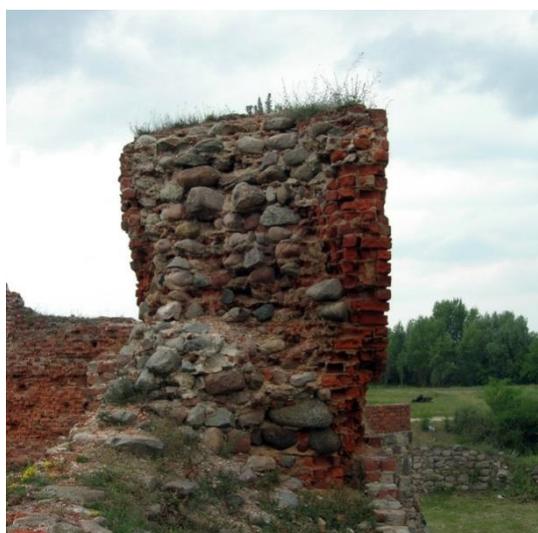
Photo11. Damages of the "opus emplectum" wall (photographer - Marek Krysiński) /Międzygórz castle/

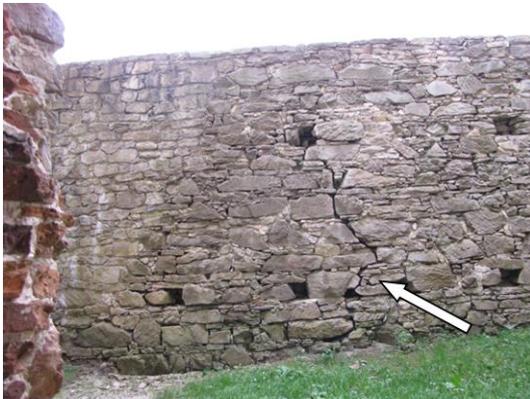
Photo12. Damage caused by uneven settlement /Krzyżtopór castle in Ujazd/

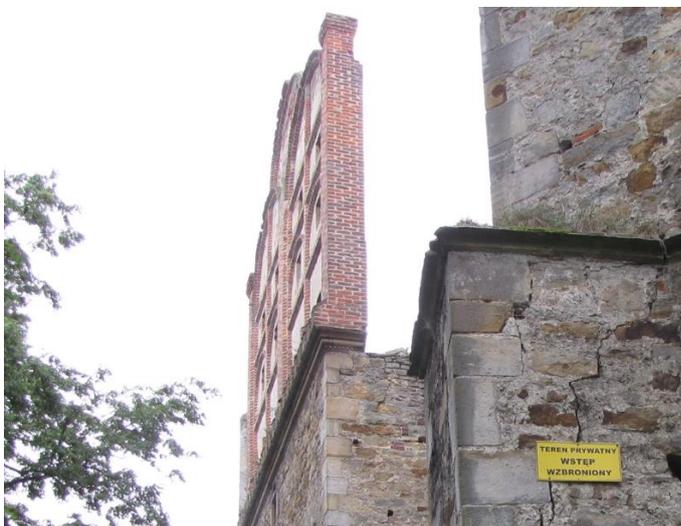
Photo14.Examples of cracks in a slender attic wall /castle in Drzewica/

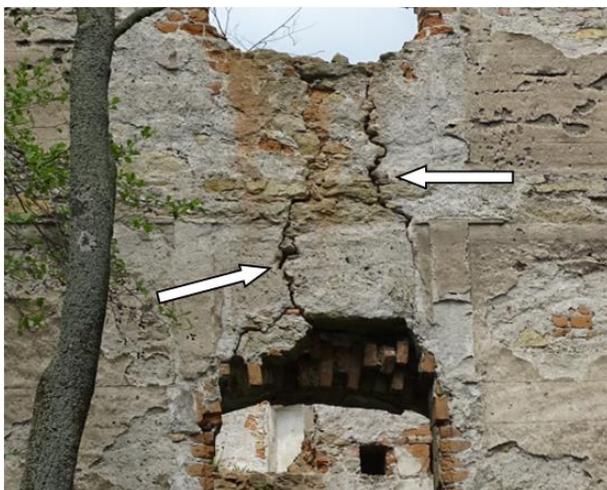
Photo15.Example of the window head's damage /Panków castle/

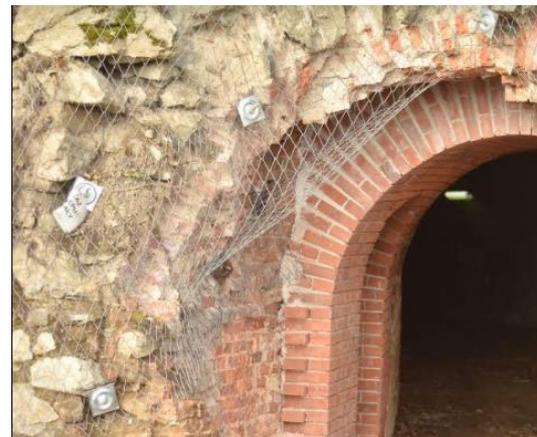
Photo17. Protection of the damaged wall's face with a steel mesh mounted by the anchors (photographer - Grzegorz Basiński)

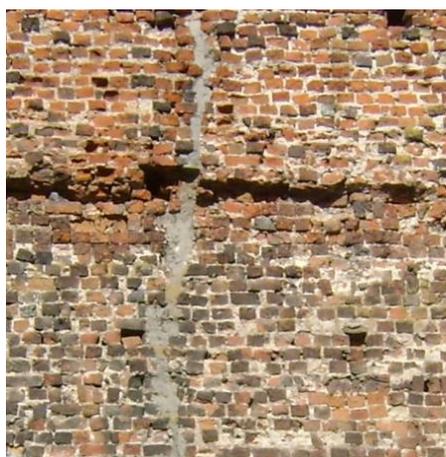
Photo 18. Injection into a crack with a cement mortar (photographer - Sylwester Zieńczuk) /castle in Liwa/

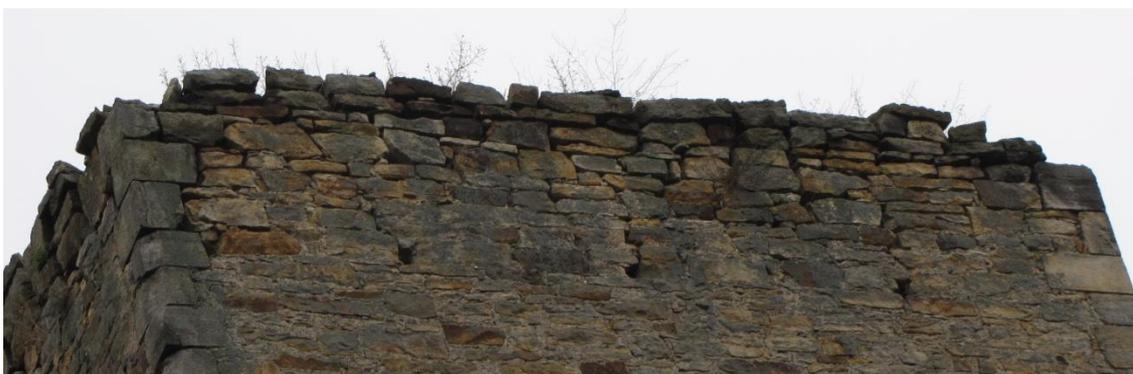
Fig. 12. Degradation of the crest of a stone wall constructed of a really durable material caused by the effect of rainfall and snowfall.

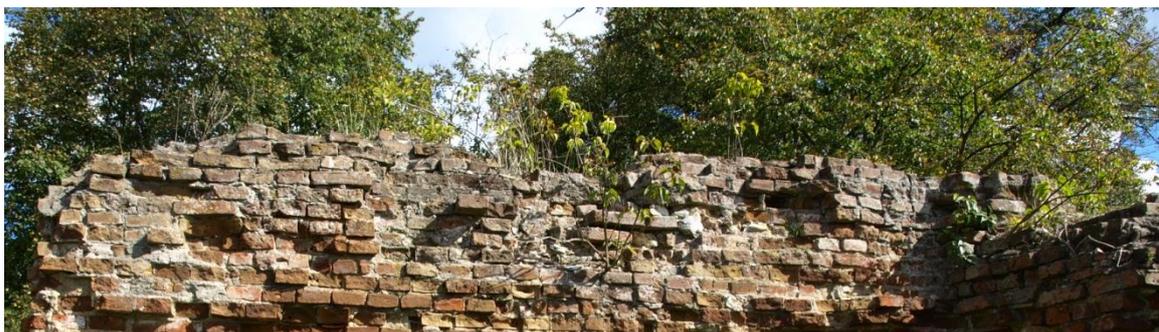
Fig. 13. Degradation of the crest of a ceramic brick wall caused by the effect of rainfall and snowfall

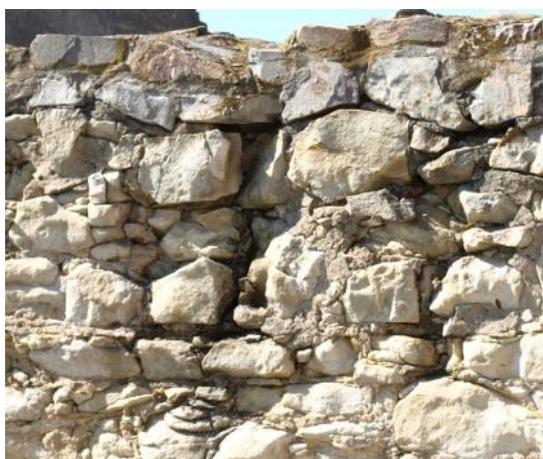
Fig. 14. Degradation of the crest of a stone wall constructed of a low durability material caused by the effect of rainfall and snowfall

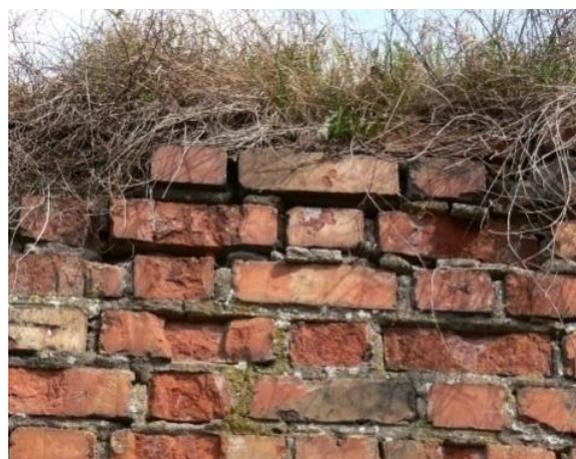
Fig. 15. Degradation of the wall mortar with a good preservation of the wall material.

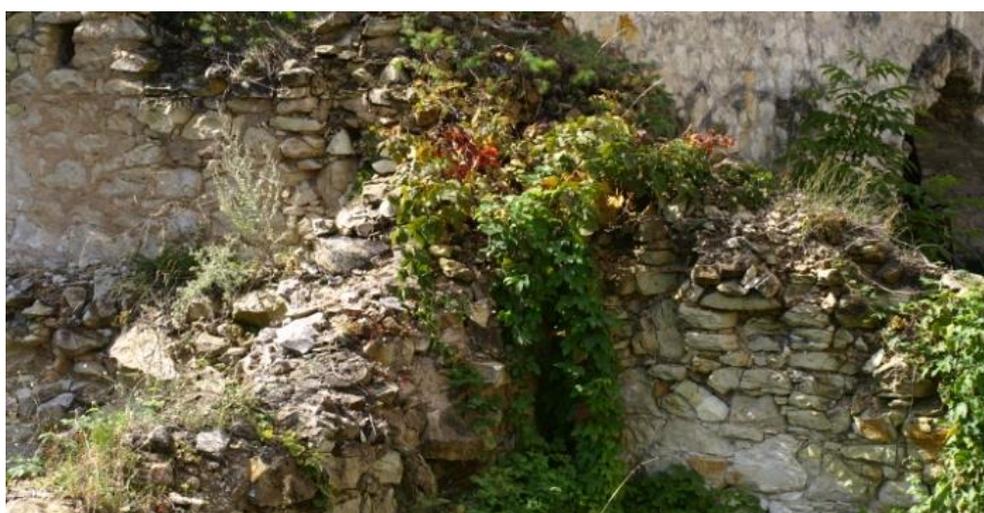
Fig. 16. A significant amount of annuals and perennials causing the degradation of the crown and the loss of legibility of the wall outline (contour).

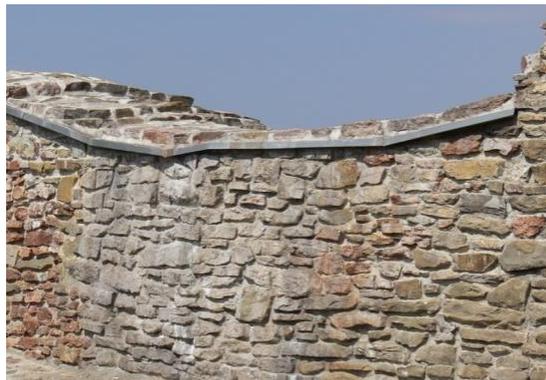
Fig. 23. Addition of the material compatible with the historical one combined with the isolation of sheet metal
