REPORT ON STUDY VISIT, TRAINING AND KNOWLEDGE EXCHANGE SEMINAR

IN VILLA BEATRICE D'ESTE (BAONE -
PADUA) AND CASTELFRANCO
VENETO (TREVISO), ITALY

Version 1
04/2018

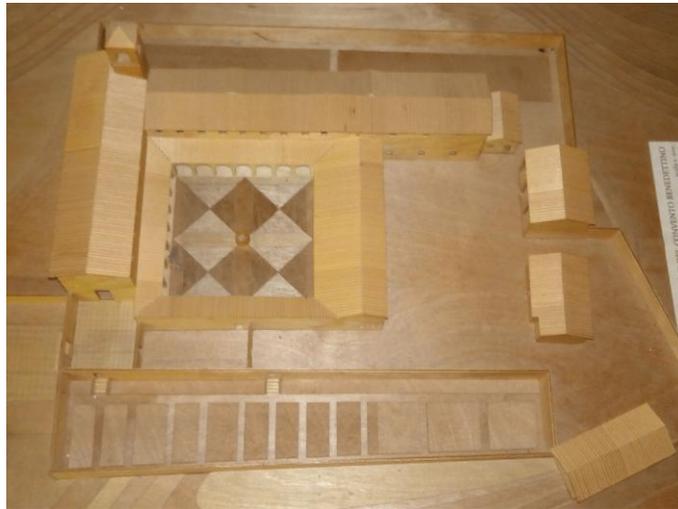
Picture 6. Wooden Mock-up of the antique monastery - Reconstruction of the original structure of the monastery from X century

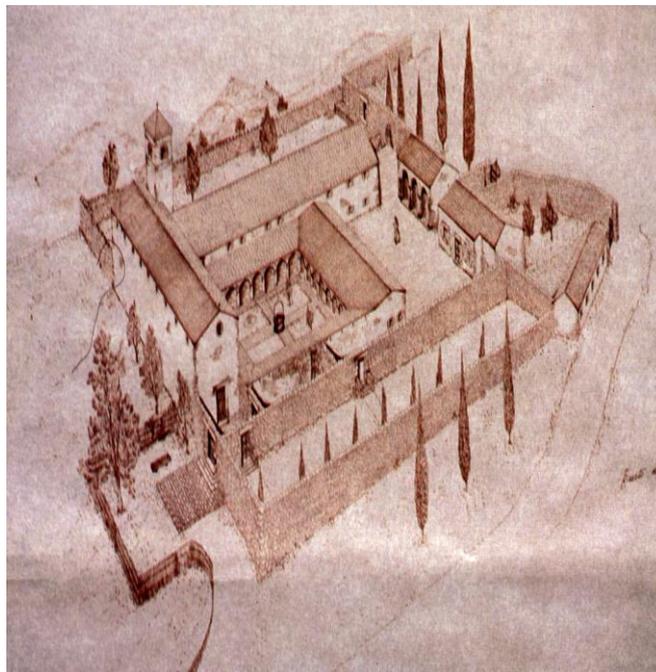
Picture 7. Graphic reconstruction of the original structure of the monastery from X century

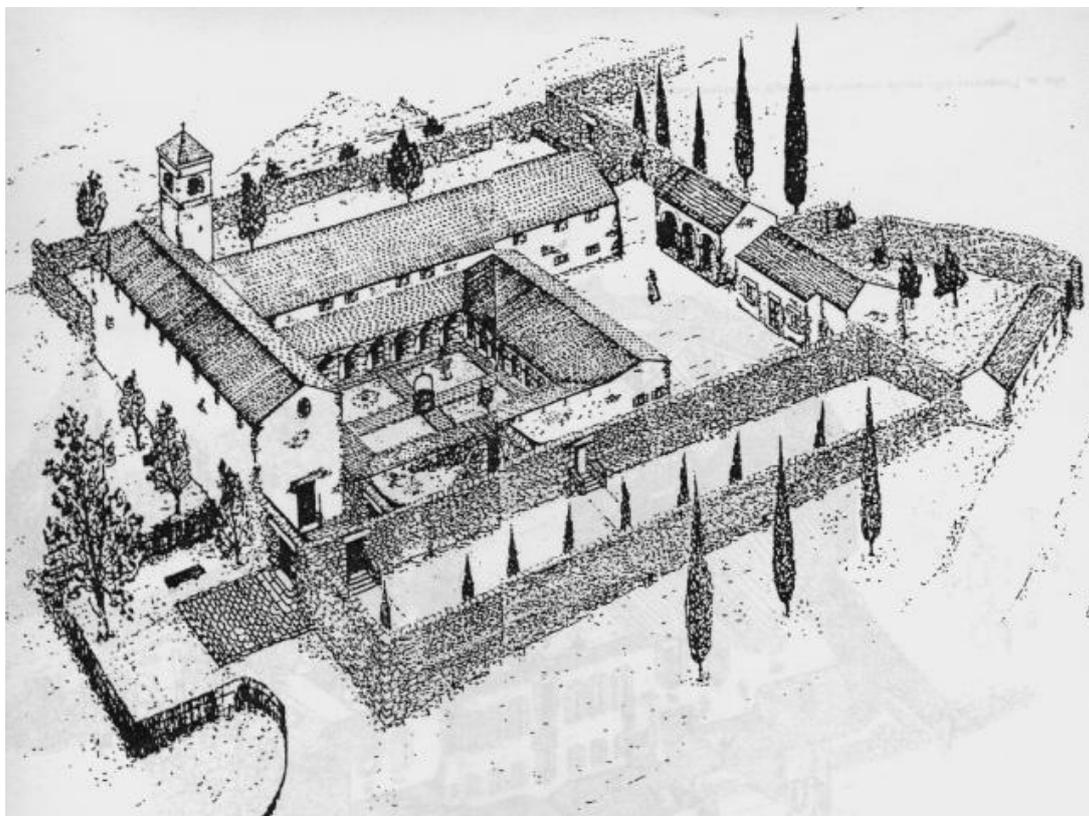
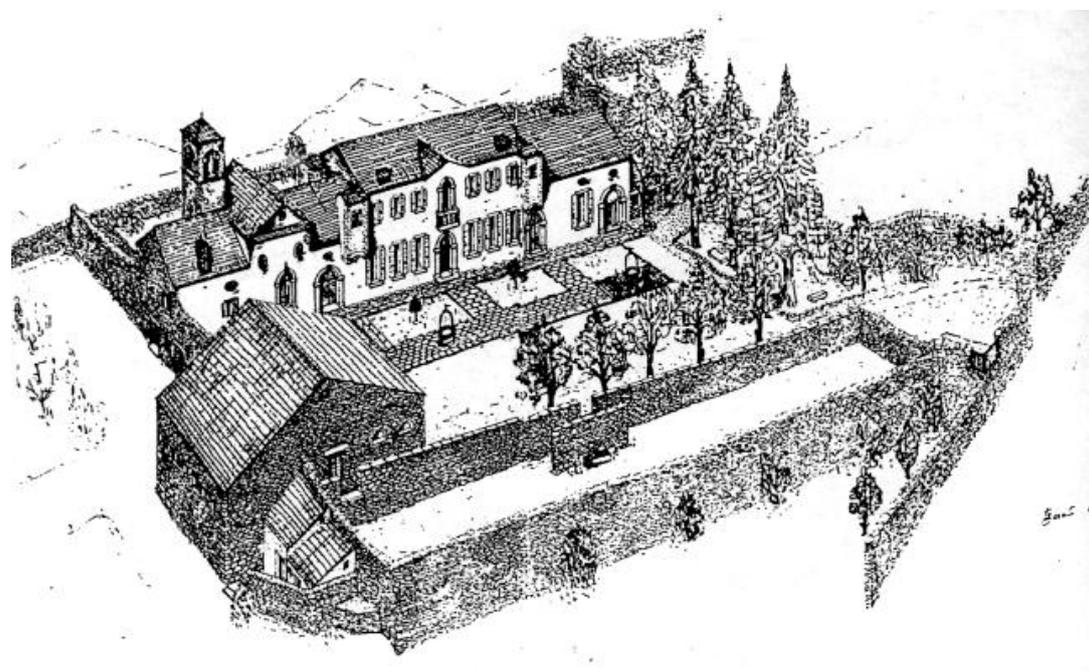
Picture 8. Comparison of graphic reconstruction of the original structure of the monastery from X century and Villa constructed on the former monastery since XVII century.

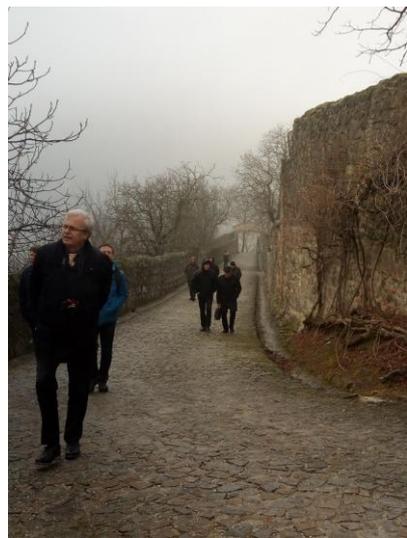
The entrance gate is followed by a long pebbled road until the hilltop and the entrance to buildings

Picture 9. The entrance gate and pebbled way to the Villa, with walls from the former monastery

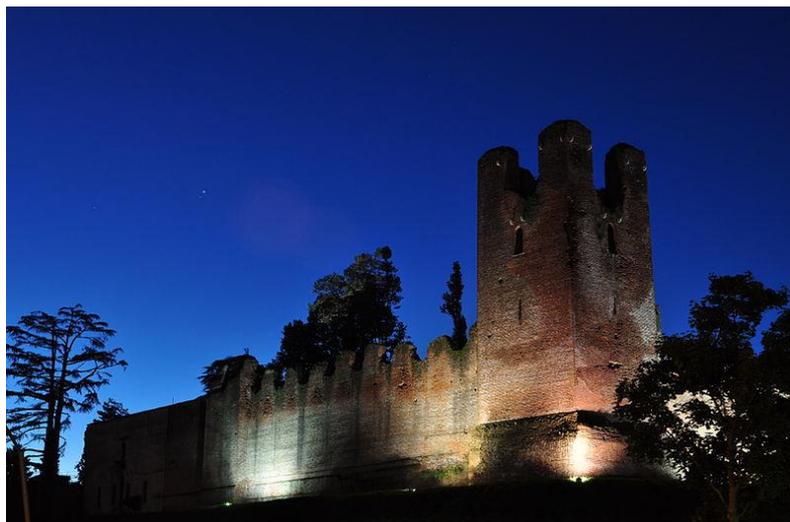
The current historic center is still defended by the 17-meter-high, 1,7-meter-thick, red-brick walls, and characterized by a series of towers: from eight original towers, today only the remain the four corner ones, the tower of the dead in the south, and above all the imposing civic tower, which is 43 meters high and which shows on the main facade a clock and the lion of St. Mark, both installed in 1499.

Picture 10. Tower and north-west walls (Picture by Dario Dal Lago)

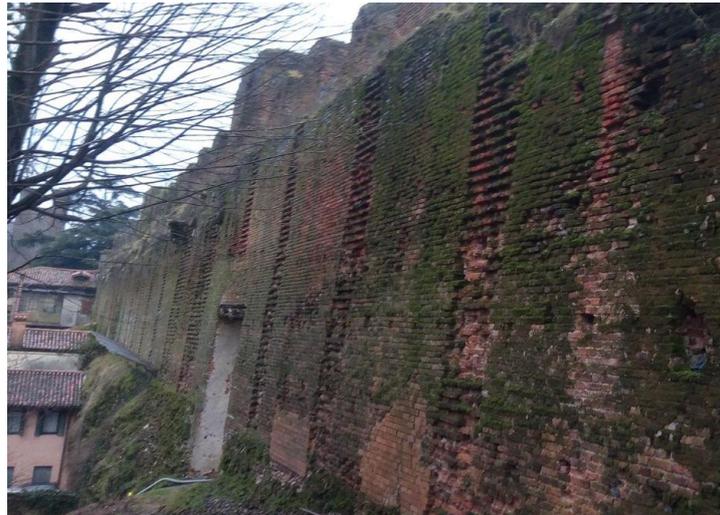
Beyond a recent renovation of the Torre Civica (2013), in recent years the restoration or securing of the city walls and towers have been reduced to a minimum, due to lack of funds and need of an integrated plan for restoration.

Picture 18. Walls still to be cleansed

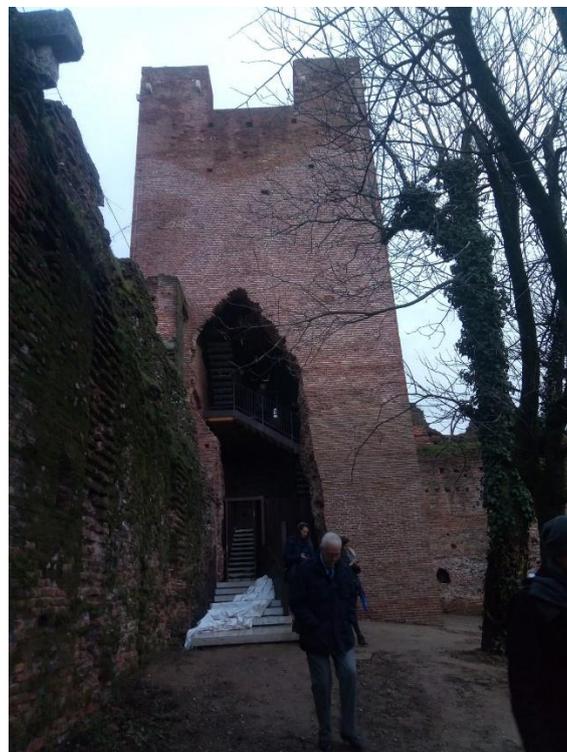
Picture 19. Tower in renovation

The bricks that make up the structure are in poor state of preservation, in fact, they present disintegrations, fractures, falls and a strong biological attack. There is also no water drainage system, and this causes problems of humidity, soil failure and therefore possible further static problems. Therefore the intervention of static consolidation of the tower must be followed by the static consolidation of the land and the surrounding walls.

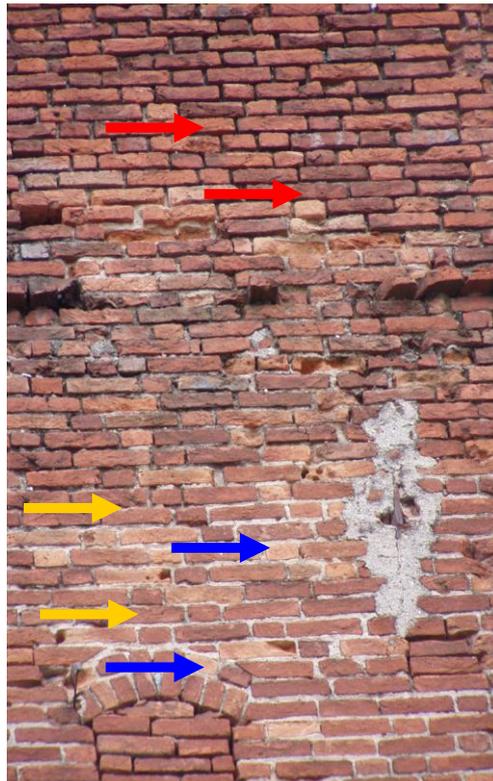
- Red-orange, good porosity and quite waterproof, medium rigid;
- Yellow-orange, friable and porous with spots of brittleness;

The whole tower and the walls are made of cooked bricks and have undergone clear rehashes through the cladding always made in terracotta. Most of the pontie pits have been left exposed. The major degradates are found in the lower fascia, but the entire surface is affected by deterioration over time.

Picture 20. Different types of bricks

1. Superficial decohesion with dusting phenomena;
2. Diffuse cracks and fissures;
3. Widespread and deep flakes and gaps with loss of plasticity;
4. Efflorescence Saline;
5. Presence of simple biological attacks and superior vegetation;
6. coating of mortar;
7. Inserts of metal elements;
8. Atmospheric dust storage;

16. Integration of the most restrained size gaps.
17. Protection of the top part of the artifact from meteoric infiltration.
18. Cleaning and sealing of the edges of the pontie holes still present on the product.

19. Cleaning of all metal parts of historical interest and subsequent protective treatment against Corrosion.
20. Subfoundation of the wall at the bottom of the walls, through the creation of a base of support in masonry of full bricks.

21. Treatment of cracks now stabilized by insertion of stainless steel bars Andor Corten, and reconnection with punctual sewing operations-SCUCI, and final clogging of the parts Open.
